Manhole Inspection Summary

Manhole # S13MM_026MH

Insp Date: **9/6/07 4:38 PM**

Location Address: **2214 DUKELAND ST**

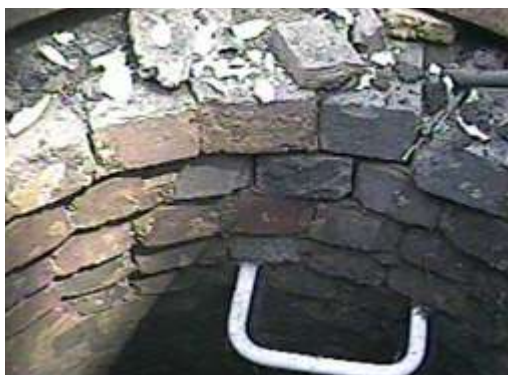
Defect 1

Condition: ☐ Sound ☒ **Cracked** ☐ Root Intrusion ☒ **Loose Brick** ☒ **Deteriorated**

CRACKED/DETERIORATTED CORBEL

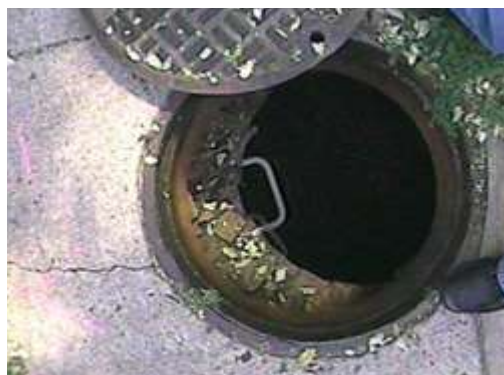
Defect 2

Offset: **6** (in.)

frame offset

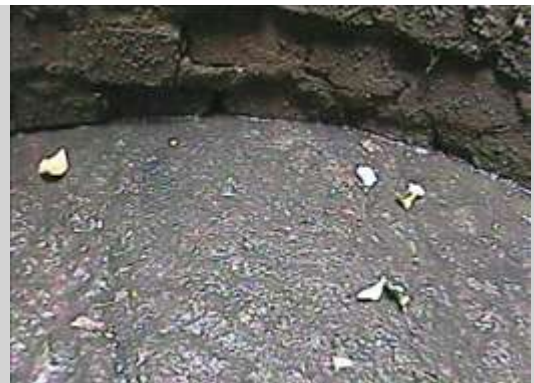
12 O'Clock Outflow

UNABLE TO SEE LINE DUE TO ACTIVE
SURCHARGE

Deposits: ☐ None ☐ Mud ☒ **Gravy** ☒ **Debris** ☒ **Grease**

Silt Depth: **8** (in.) Deposits Extent: **Heavy**
